Space Shuttle Program

SSME Flight Readiness Review

June 28, 2001

SSME BLOCK II

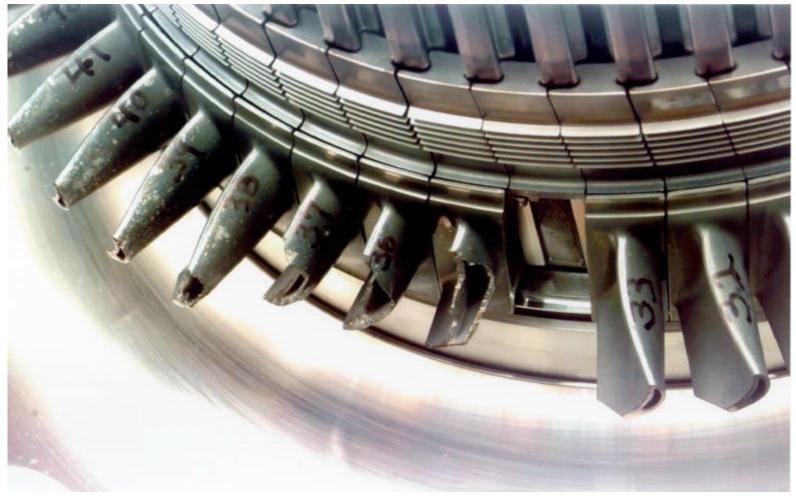
Blade Cracking Failure – 7/1/96

Damaged Turbine Blades (8-1a)

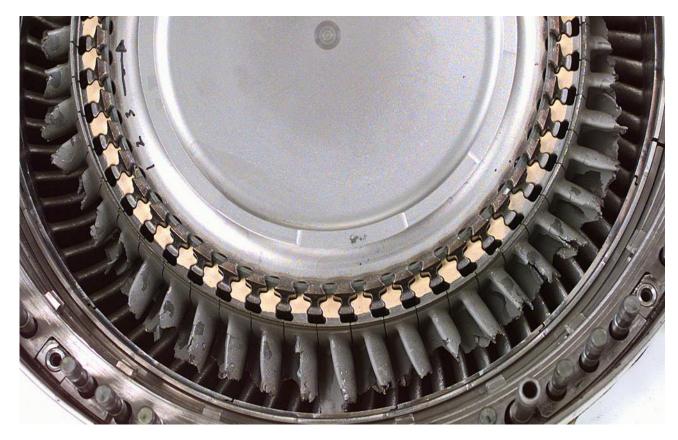
Foreign Object Obstruction in Fuel Preburner - 6/16/00

Damaged Turbine - SSME 0523

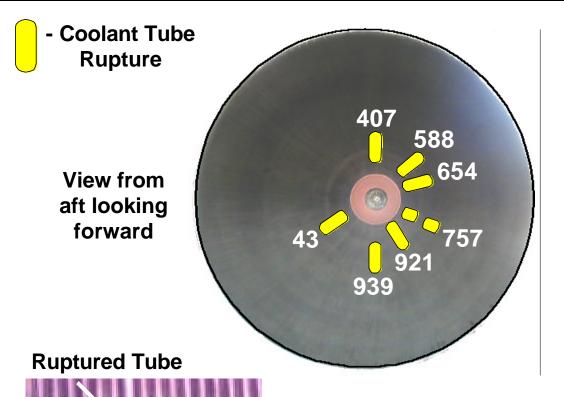
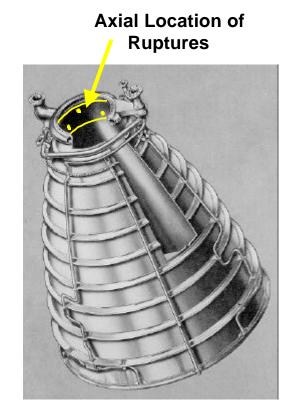
Nozzle Condition Post 902-795

Nozzle tube hot-wall ruptures observed post test 902-795

- Ruptures indicative of fuel system contamination
 - 8 total ruptures noted in 7 tubes
- 17 prior occurrences of contamination related tube ruptures
 - Coolant flow blocked, tube overheats and ruptures
 - All Crit 3 failures with no additional engine damage
- Test 902-795 completed planned 520 second duration
 - No other engine damage

- Contamination observed in turbine and pump inlet and discharge of HPFTP 8018 post 902-794 (ruptures occurred during next test)
 - Identified as Viton (O-ring material: 3/8" x 3/16" x 1/8" max size)
 - O-ring mold surfaces identified (0.210" cross-section dia.)
- Subsequent disassembly of E0525 Main Fuel Valve also revealed Viton particles
 - Dust and particles entrapped within deadheaded cavities
- No Viton utilized in engine fuel system
- Viton O-Rings utilized in GSE (Canoga, SSC and Pratt & Whitney)
 - Various leak test and flushing fixtures and tooling
- Search for source ongoing
 - Cryogenic fracture surfaces verified
- Next test (902-796) conducted with no anomalies
 - Additional single tube rupture occurred during test 902-802
 - Likely from residual entrapped contamination

Rationale for Flight

- No contamination found in STS-104 engines during flight processing
 - Minimal opportunity to introduce contamination
- All turbopumps are green run at SSC prior to flight
 - Potential contamination flushed during ground test
- Contamination related tube ruptures are Crit 3
 - 19 occurrences in over 2870 starts and 942,000 seconds of operation
